## AIR EMISSIONS AND DIOXIN IN SOIL AND VEGETATION AROUND A METAL RECLAIMING PLANT IN DENMARK

Ole Schleicher<sup>1</sup>, Peter Blinksbjerg<sup>1</sup>, Allan A. Jensen<sup>1</sup>, Peter Wade<sup>2</sup> and Bernd Schilling<sup>3</sup>

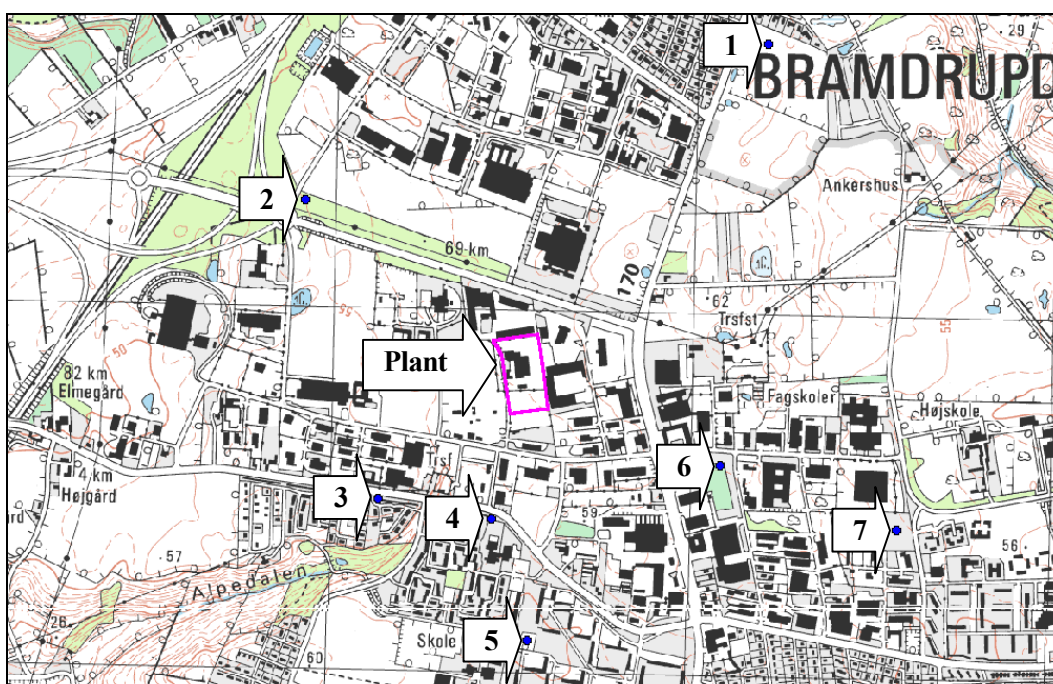
Figure 1. Sampling positions around the metal reclaiming plant.

The seven sampling sites around the plant are shown in Figure 1, and the dioxin concentrations measured in the samples are shown in Table 2.

The samples from position 6, both the soil and the vegetation sample, are higher and much higher than the samples from the other sites. This position is situated in the prevailing wind direction from the plant, and the area was polluted with different types of waste, including plastic and old tyres. The elevated concentration could be influence from the plant, but it could as well be other local sources, indicated by the waste. Other investigations have shown, that vegetation samples typically have higher dioxin concentration than soil samples from the same site, which is also the situation here.

Slightly elevated dioxin concentration in both soil and vegetation was found at position 6, which is in the prevailing wind direction from the plant, but the reason could also be a local pollution indicated by the observation of littering in the area.

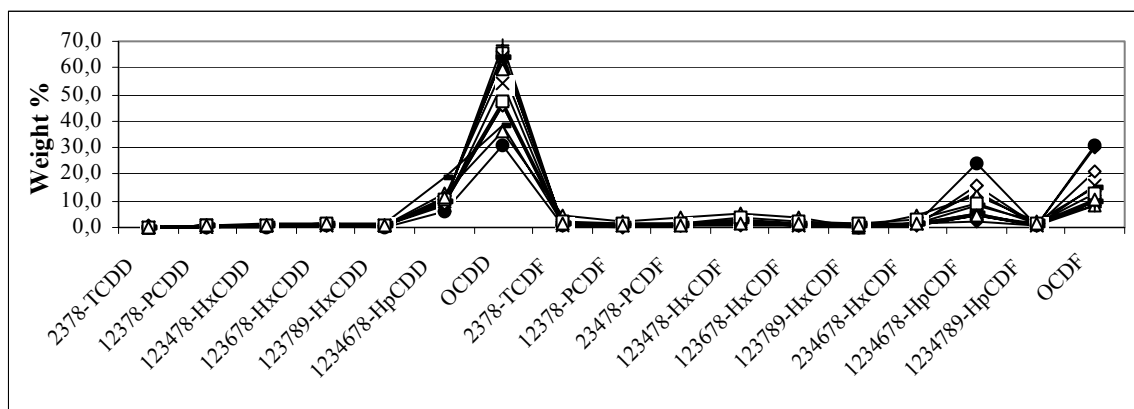
Figur 2. Dioxin congener pattern for soil and vegetation samples.

Dioxin congener patterns in all the samples have been examined in order to evaluate, whether the emission from the plant could be directly related to the dioxin found in the soil or vegetation samples. The congener pattern was calculated in percent of contribution of every native congener, to make it possible to compare all the different patterns, independent of the concentrations. Previous investigations /4 / have shown the possibilities to distinguish between the contribution from different sources by using this kind of comparing the dioxin pattern. The pattern for the soil and vegetation samples is shown in figure 2, and the pattern for some of the emission samples is shown in figure 3. All profiles are very similar to each other, despite pos. 6 is 10 to 20 times higher in concentration.

A comparison between the dioxin patterns for the emission samples and the soil and vegetation samples does not show a great conformity. The pattern for the extremely high emission sample is very different from the soil and vegetation samples, and the unusual very high concentration of the low chlorinated furans, cannot be recognized in any of the soil or vegetation samples. On this basis, the measured and potential former high emission from the metal reclaiming plant cannot be identified as a major contributor to the dioxin deposition in the near surroundings. The pattern supports the assumption that the very high dioxin emission has only occurred for a shorter time. The other dioxin patterns shows more similarity with the soil and vegetation samples, but as they also look like profiles from MSWI plants, where one is situated a few hundred metres away, the potential contribution from the metal reclaiming plant cannot be distinguished from other sources.

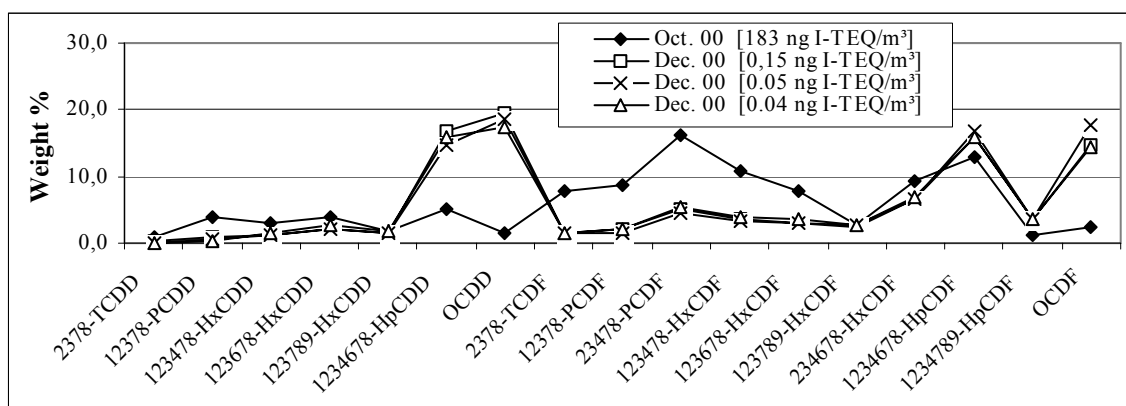
Figur 3. Dioxin congener pattern for emission samples.

Apparently, the cause of the extremely high level at 180 ng I-TEQ/Nm<sup>3</sup> was a wrongly adjusted natural gas burner. This is supported by the analysis of the dioxin pattern, which is remarkable

different from the other samples. The dioxin patterns in the other samples are rather identical and look more like dioxin patterns from common MSWI plants.
