## LONG-TERM ASSESSMENT OF PCB EMISSIONS FROM LARGE SCRAP METAL RECYCLING PLANTS IN THE FLEMISH REGION (BELGIUM)

J. Van Hoeymissen<sup>1</sup>, M. Blondeel<sup>1</sup>, P. Bernaert<sup>1</sup>

<sup>1</sup>*Environmental Inspectorate Division of the Flemish Government, Graaf de Ferraris-gebouw, Koning Albert II-laan 20 bus 8, B-1000 Brussel, Belgium*

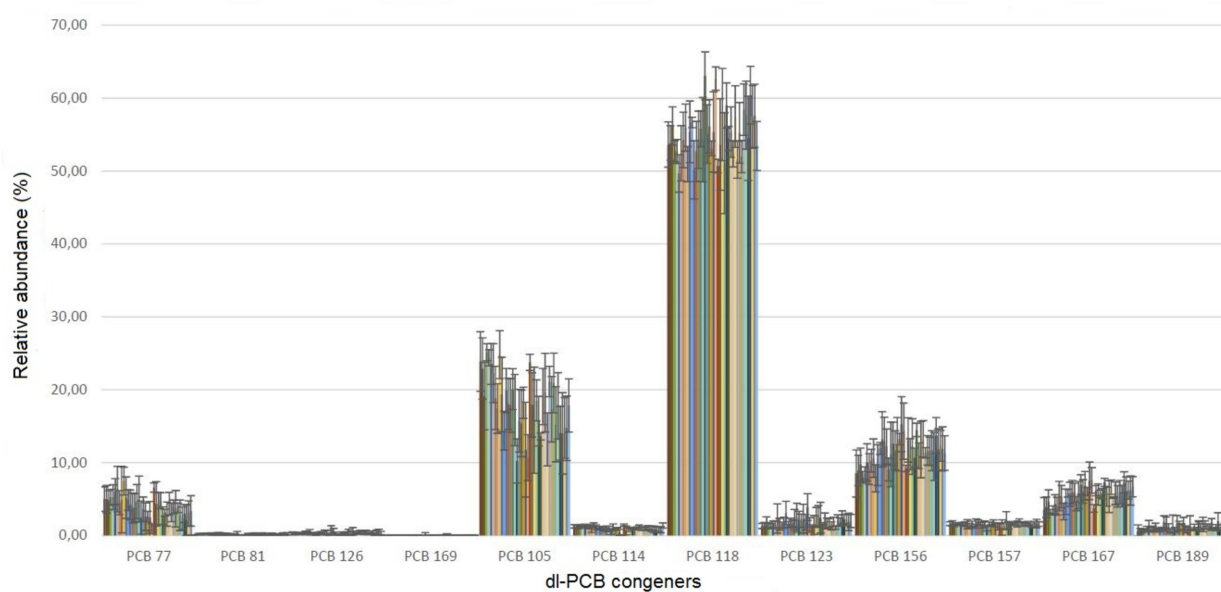
Figure 1. Relative abundance of the dl-PCB congeners of 41 deposition samples. The different colors represent different sampling locations and/or different points of time. Error bars represent one standard deviation.

- Characterization and identification of the PCB fingerprints: The whole dataset of iPCB and dl-PCB fingerprints, in all media (air, water, solid), collected by EID and VMM over the time span of several years, was treated statistically (5). It was shown that all the detected PCB, independent of location, medium or sampling time, belong to the same 'population'. A typical resulting fingerprint of the dl-PCB, in this case of the deposition samples, is displayed in figure 1.

This means that either the detected PCB originate from the same source(s)/application, or that only the most weathering-resistant congeners have been measured. It is currently not clear which option is the most likely.

This resulting fingerprint could be reproduced by a mixture of 33% Aroclor 1254 and at least 33% of a relatively low-chlorinated Aroclor (1221, 1232 and/or 1242). These Aroclors were mainly used as isolation liquids in (large industrial) capacitors and transformers all over the western world.
